Re: Hawkesbury CIP Outfall Remediation- Outfall Inspection...

October 24th 2007

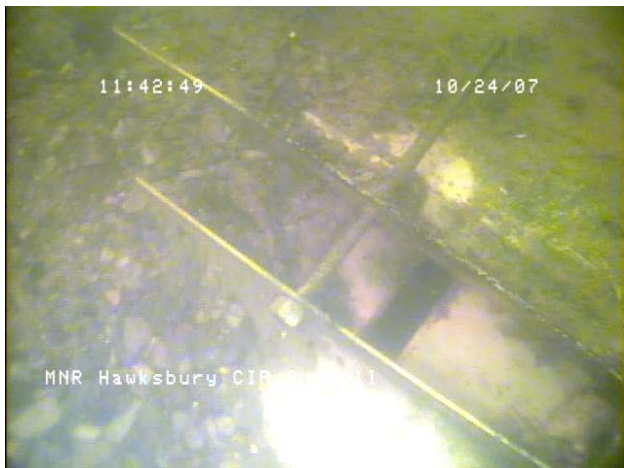
S.S. Clamp at joint in pipe (photo 1)

- The first location was at a joint in the pipe. A stainless steel clamp is visible with a small gap in the pipe where the clamp does not cover. (see photo 1)

- The depth of water to the top of pipe was approx. 12 feet.
- The second location had a very small area of the top of pipe exposed.
 - GPS coordinates 18T 0530375 UTM 5051284

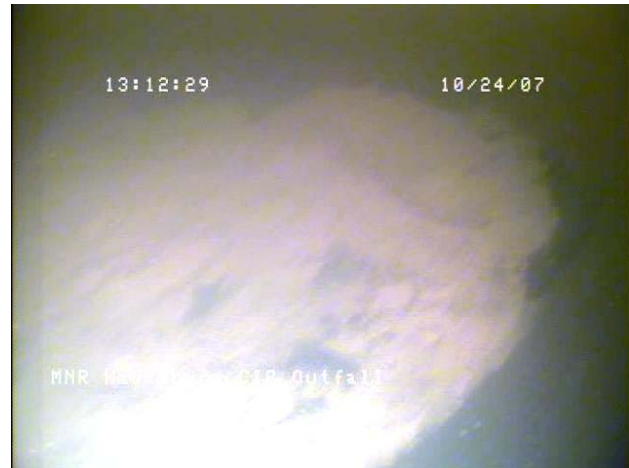
Broken end of pipe on support (photo 2)

- Diver located end of pipe. A 1m long section of broken pipe on a saddle support is the only evidence of the end of the outfall. Diver could not locate pipe coming out of berm. It would appear the outfall pipe has completely failed. The berm has collapsed and/or covered the pipe completely. Depth of water at this location is approx. 16 ft. The natural bottom consisted of small cobble and sand with the back fill consisting of larger stone. (See Fig. 1)
