Re: Hawkesbury CIP Outfall Remediation- Outfall Inspection...

October 24th 2007

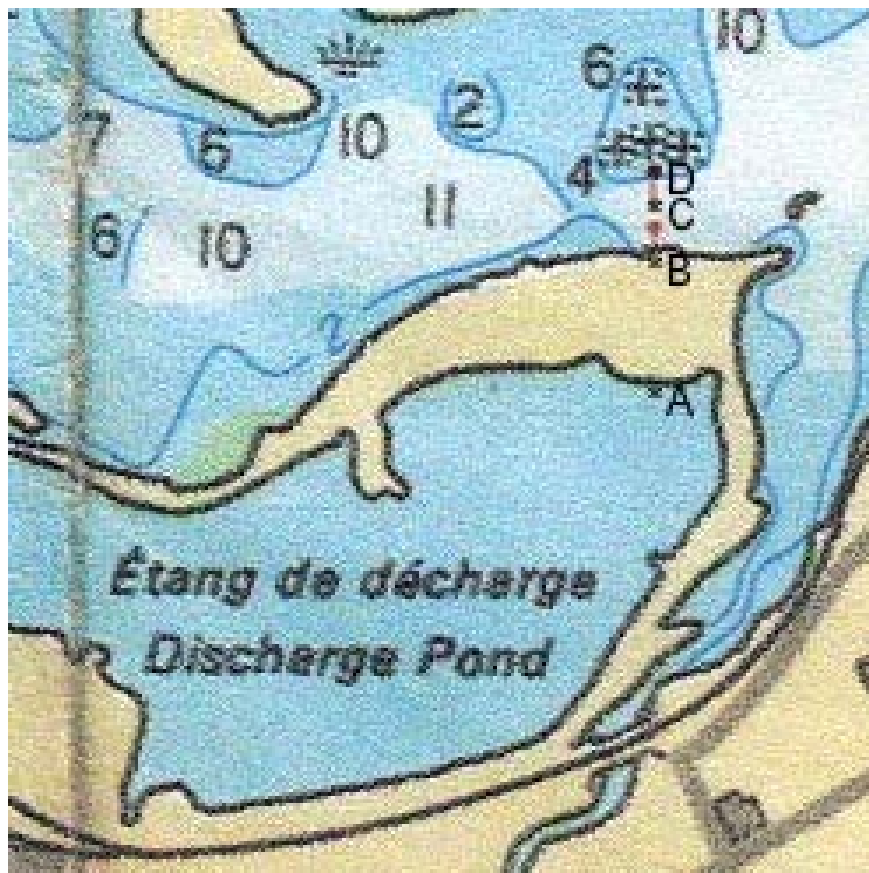
GPS Locations:

- (A) Inland Outfall Structure.....18T 0530332 UTM 5051112
- (B) Shore.....18T 0530339 UTM 5051166
- (C) Exposed pipe @ joint.....18T 0530336 UTM 5051224
- (D) Broken End of Pipe.....18T 0530391 UTM 5051284
